How Structures Withstood the Japanese Earthquake and Fire

H. M. HADLEY

District Engineer in Charge of Seattle Office, Portland Cement Association

One of the papers presented at the Twentieth Annual Convention of the American Concrete Institute held in Chicago, February 25-28, 1924

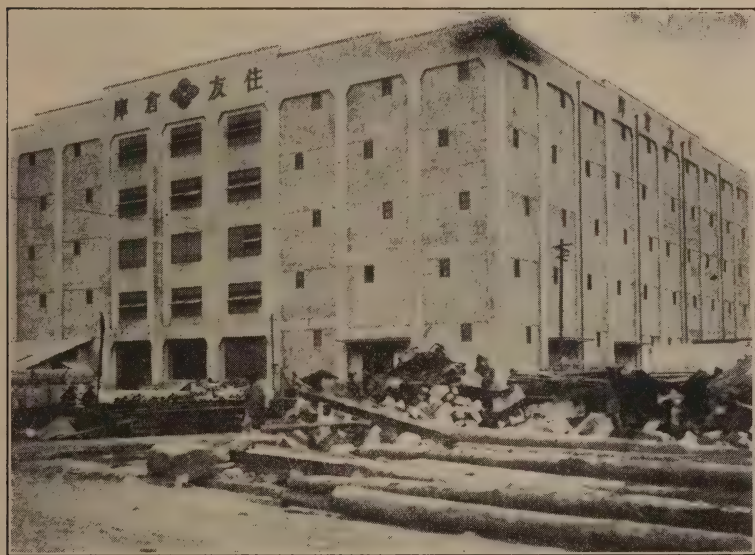
FIG. 2.—SUMITOME WAREHOUSE—TOKIO.

West and South elevations. 180 x 200 ft. high. Filled with heavy storage valued at \$4,000,000 at time of earthquake.

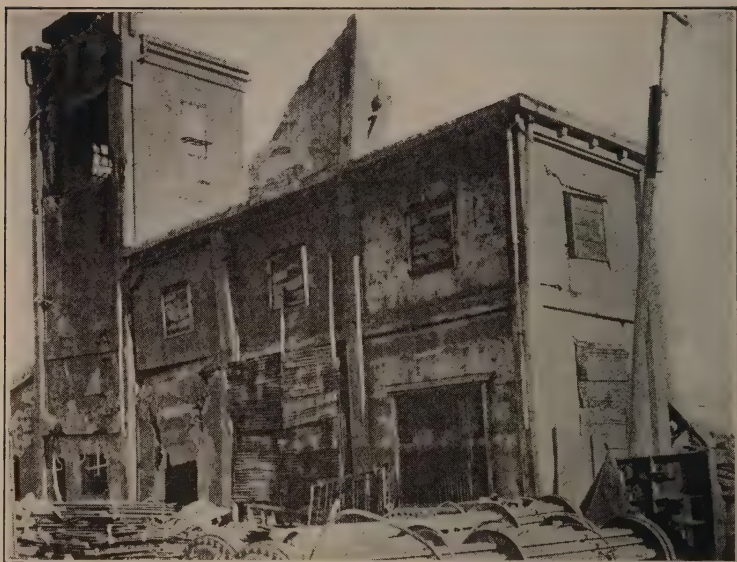
FIG. 3.—REINFORCED-CONCRETE WAREHOUSE AT HIGASHIKANAGAWA.
Wreck due to foundation settlement.

building into the soft ground under the shaking effect of the earthquake. Where individual footings are used they should be connected with beams of sufficient strength to maintain them at all times in their normal relative positions.

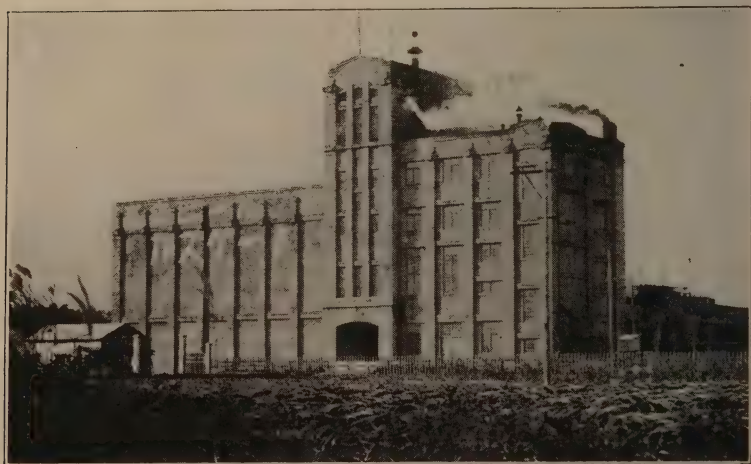
FIG. 4.—CASCADE BREWING CO.—TSURUMI.
Reinforced Concrete. Only minor damage done to main building shown in photograph.

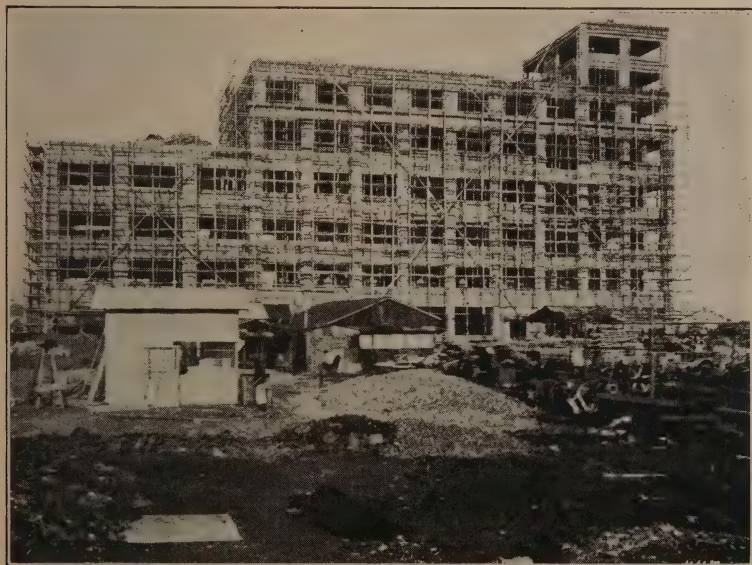
FIG. 5.—REINFORCED-CONCRETE GRAIN ELEVATOR AT HIGASHIKANAGAWA.

In this stage of construction when earthquake occurred. One of the largest reinforced concrete structures in earthquake zone. Practically undamaged. Good pile foundations.

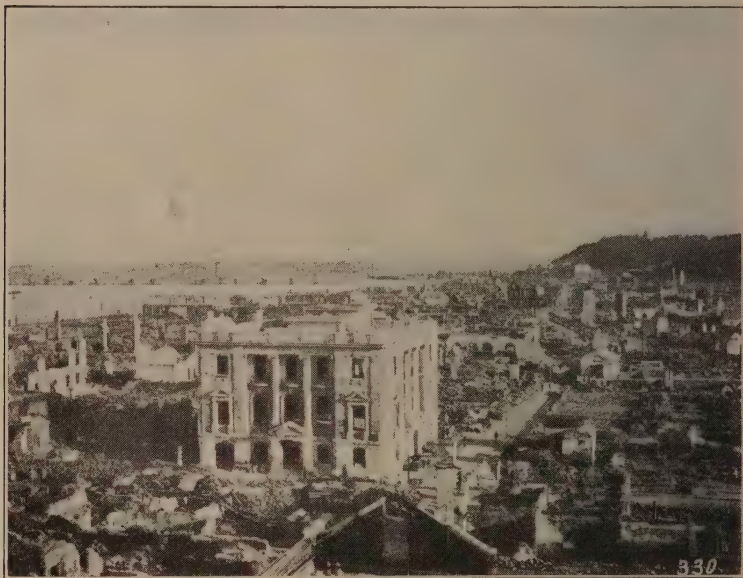
FIG. 6.—PHOTO SHOWING GENERAL DESOLATION AT YOKOHAMA.
Russo-Asiatic Bank Building.

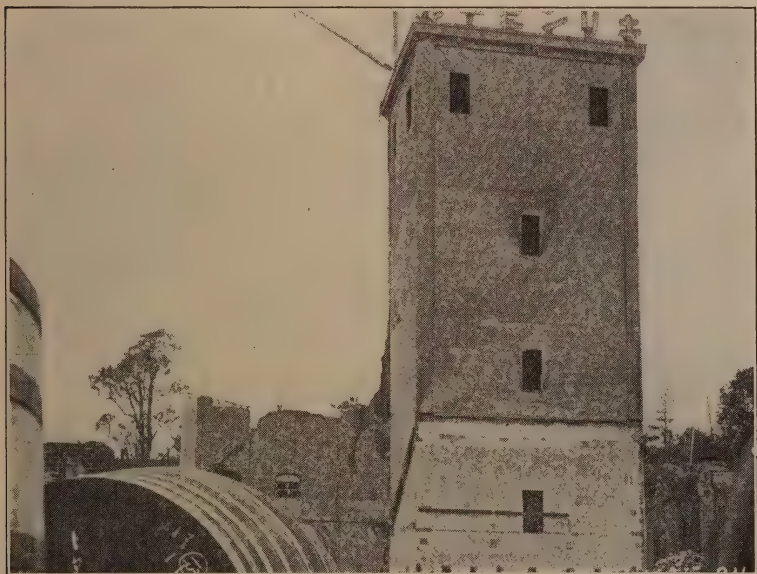
FIG. 7.—KIRIN BREWERY—YOKOHAMA.

Photo shows undamaged reinforced concrete tower used for malt and hops storage.

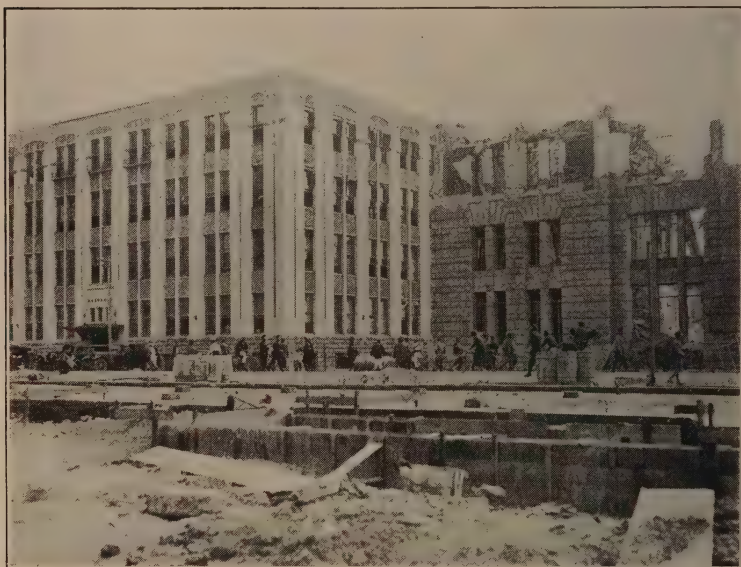
FIG. 8.—ABSOLUTELY UNDAMAGED REINFORCED-CONCRETE BUILDING ON BLOCK IS MARUNOUCHI CENTRAL, TOKIO.

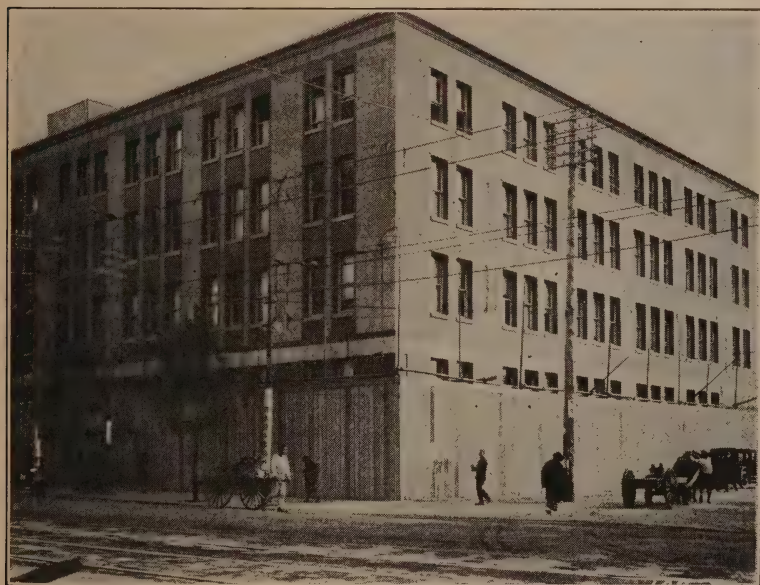
FIG. 9.—TEMPORARY QUARTERS OF YOKOHAMA SPECIE BANK.

Reinforced concrete and brick filler walls. Damage due to brick filler walls.

Fundamentally the weakness of brick masonry is its low tensile strength which is insufficient to withstand the bending and swaying that an earthquake causes unless the walls be of considerable thickness and be well stiffened by the floor systems or heavy division walls.

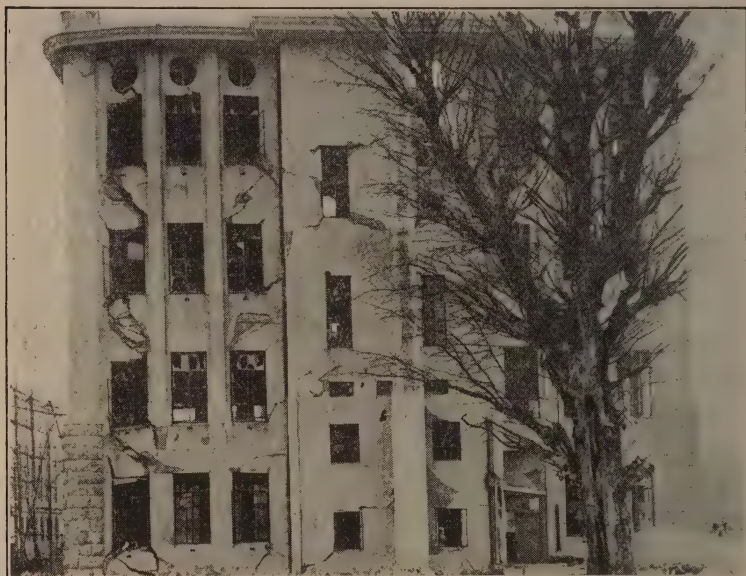
FIG. 10.—PATENT OFFICE EXHIBITION BUILDING—TOKIO.

Rear North Elevation. Reinforced concrete. Failure due to inadequate foundations causing a 2-ft. settlement.

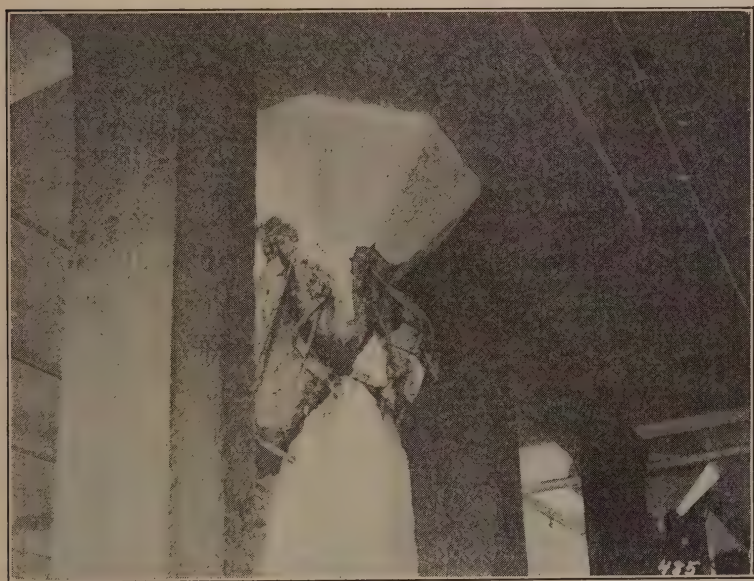
FIG. 11.—INTERIOR VIEW SHOWING BADLY DAMAGED FIRST STORY COLUMN IN BUILDING NO. 25 OF INDUSTRIAL PLANT AT KAWASAKI

Shows absence of spiralling and very light binders.

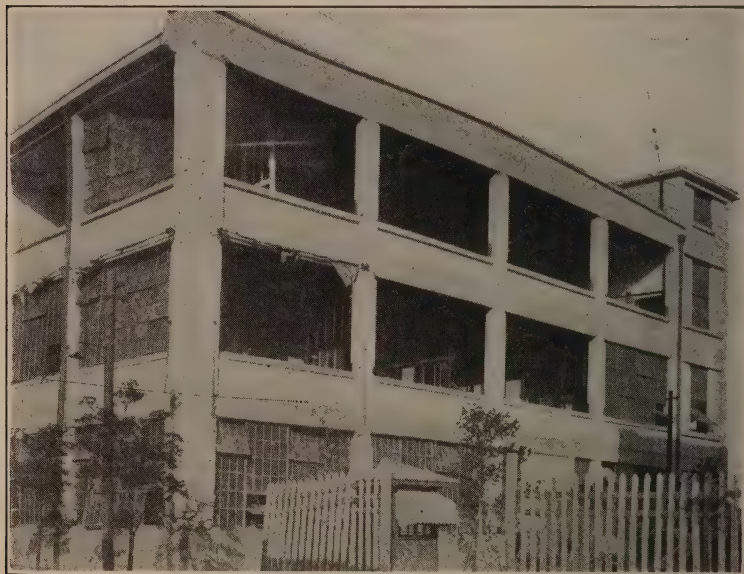
FIG. 12.—BUILDING NO. 18, INDUSTRIAL PLANT AT KAWASAKI, BETWEEN TOKIO AND YOKOHAMA.

Reinforced concrete. Damage caused by poor foundations and lack of rigidity.

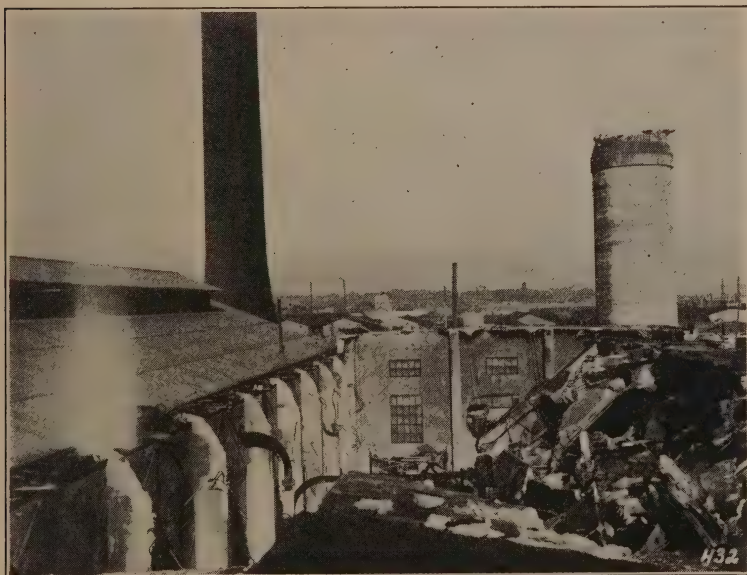
FIG. 13.—POWER PLANT AT HIGASHIKANAGAWA.

Reinforced concrete boiler house. Failure due to faulty engineering design. Heavy roof was not anchored, tore free from the columns and fell.

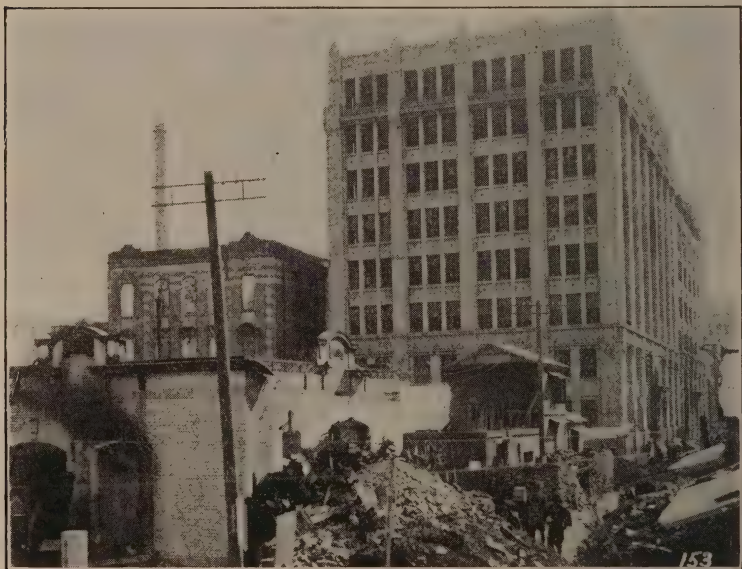
FIG. 14.—MITSUI NO. 3 BUILDING—TOKIO.

North and West elevations. Reinforced-concrete—110 ft. high. Guttured by fire—uninjured by quake. Debris in foreground from adjoining brick structures. Concrete stack at left on Mitsui No. 4 Building.

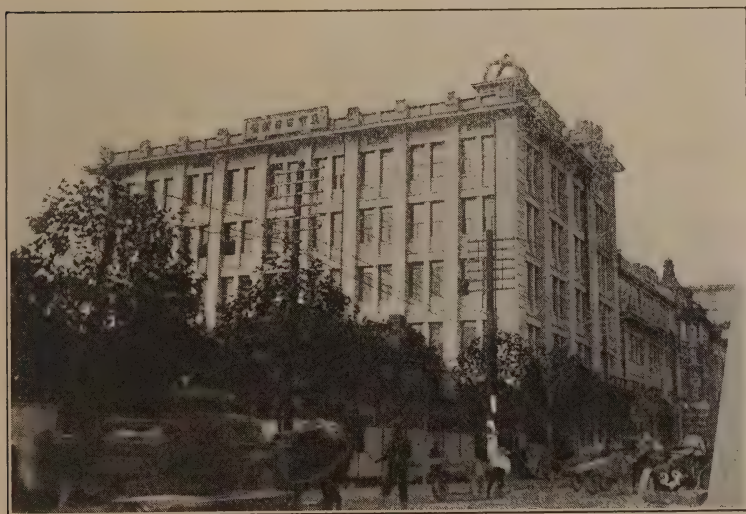
FIG. 16.—NICHU NICHU BUILDING—TOKIO.

Reinforced concrete. No damage.

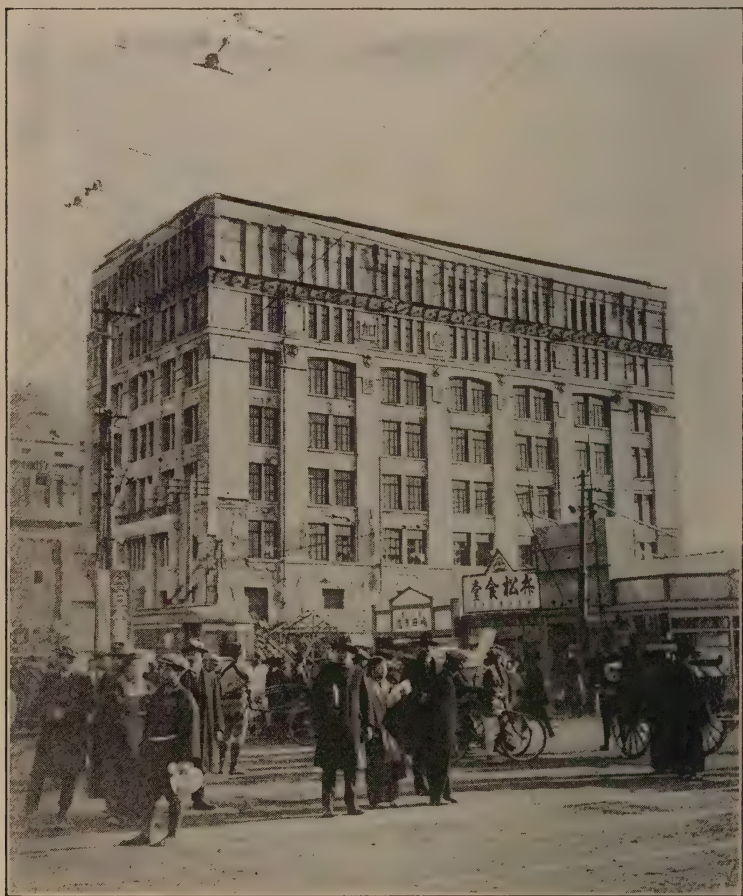
FIG. 19.—KASHIMA BANK BUILDING—TOKIO.

Reinforced concrete. Burned by fire. Undamaged by quake.

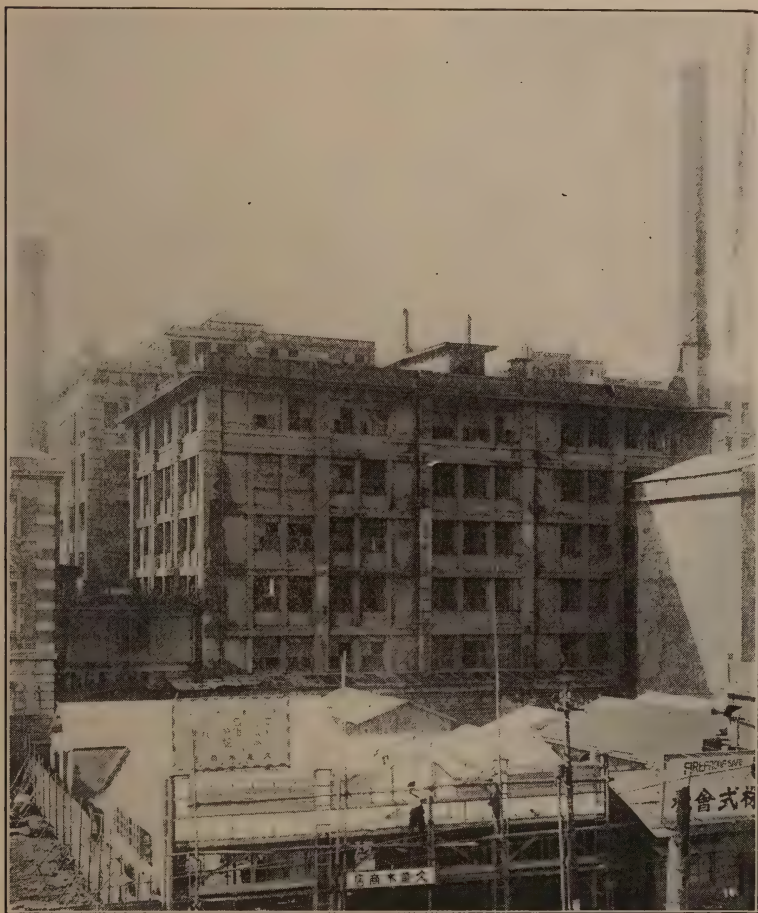
FIG. 20.—MITSUI NO. 4. BUILDING.

Reinforced concrete. Gutted by fire. Undamaged by earthquake and does not have a crack in it.

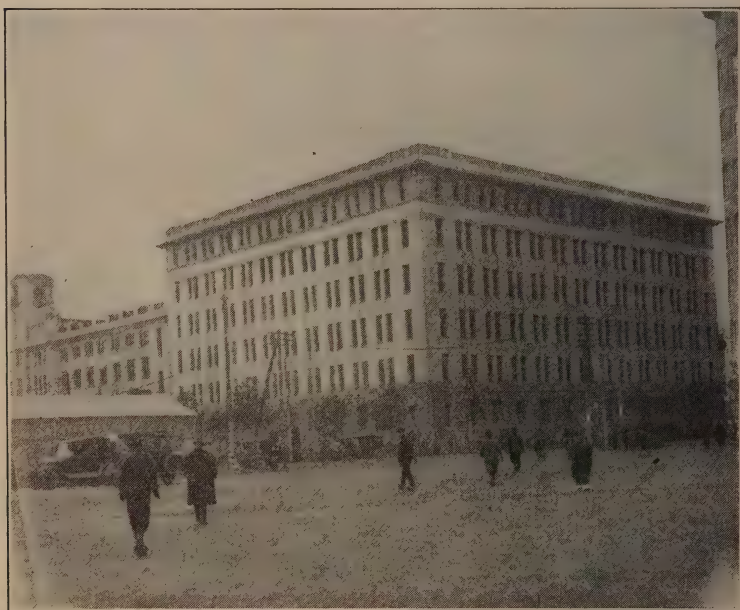
FIG. 21.—MITSUBISHI HEAD OFFICE BUILDING—TOKIO.

Reinforced concrete—tile and stone veneer. Undamaged.
